The MANTRA 2004 Campaign

POST-FLIGHT REPORT

November 30, 2004

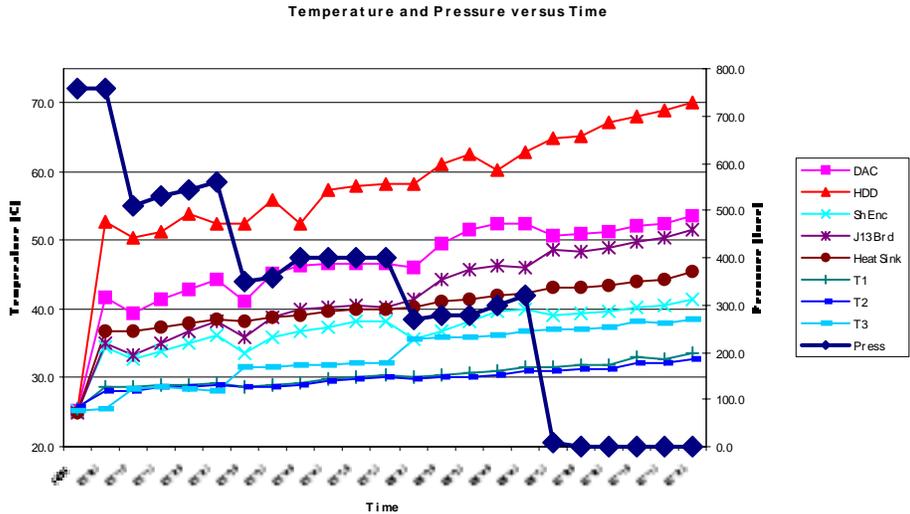
The TVAC tank was pumped down in stages to observe any signs of thermal runaway. The unit was left at one Torr for half an hour. Other than the hard drive, the temperatures showed signs of equilibrium that were within safety limits. The ambient temperature specification for hard drives is usually 70C, so a case of 70C should be within these limits.

The rest of the tests concentrated on the pointing system functionality as it was cooled. In the end, LN2 was circulated through the copper coils to cool the joint sufficiently. The joint operated at after cold soaking it at -40C in a vacuum.

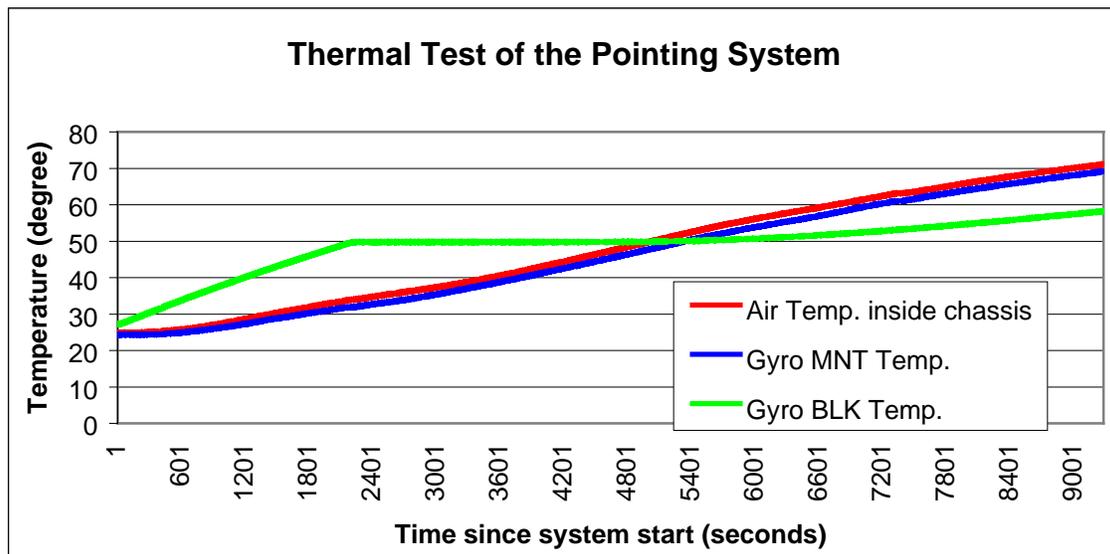
The pointing system, in common with other instrumentation, was operational during launch. The system was engaged in solar mode at 08:53 (local time). After fine-tuning azimuth PID controller was attempted and the command link failed, the pointing system was left in solar mode for the remainder of the first flight, with the velocity feedback and sun sensor for D-term succeeding until the last pointing data was received at around 16:16 (local time). At that time, the pointing system's computer in the payload crashed. The higher temperature around the single-board-computer (SBC), which was over 68°C during the latter period of the first flight, may have caused the SBC crash. On October 20 in SIL, this assumption was proven through thermal testing of the pointing system, where the environmental temperatures of the first flight were simulated. The following figure shows SBC of the pointing system crashed again at around 69°C. This test also indicated the best performance of the electronics including sensors, circuit boards, and cards of the pointing system at a range of 10°C to 55°C.

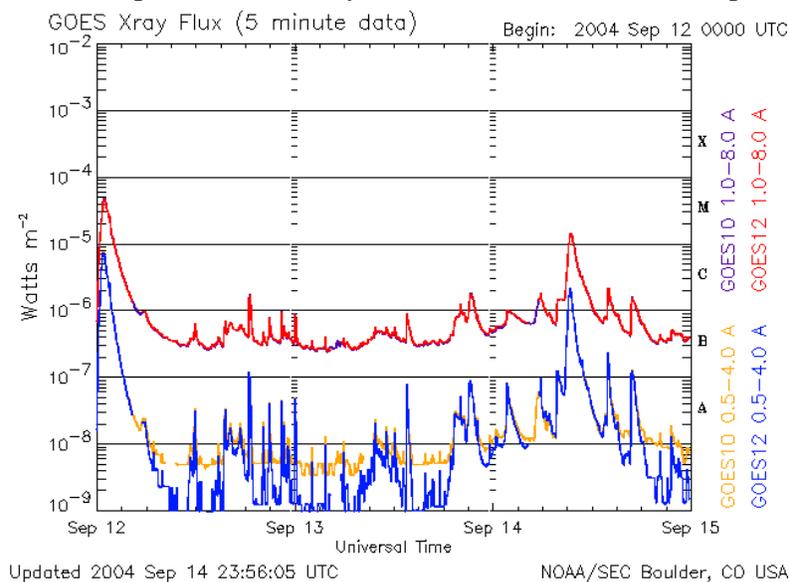
Figure 3 – SEC GOES Satellite X-ray Flux

On the launch date after premature termination had been confirmed, some information was given to SIL by Stella Melo. The graph given showed X-ray Flux as detected by a GOES Satellite (Figure 3) from the Space Environment Center in Boulder Colorado. The graph shows heightened electrical activity throughout the launch and recovery window. It is not known how widespread this activity was over the northern hemisphere.

Also of note is the fact that there were rain clouds in the area during the launch. Electrical activity accompanies rain and that could have been a contributing factor to the premature termination.

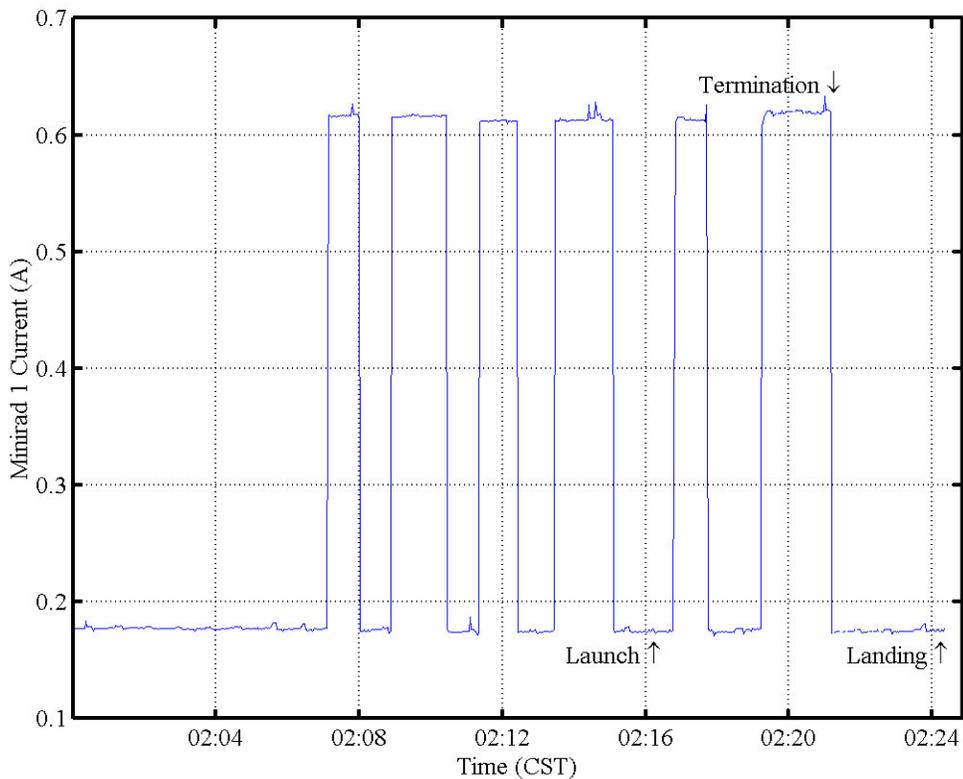
Figure 4 – Mantra 2004 (second flight) Minirad 1 Current vs Time

The SIL monitor data was also examined for unusual activity. At the time of termination, the current drawn by Minirad 1 dropped by approximately 450mA. A plot of the current versus time is shown in Figure 4.
