The MANTRA 2004 Campaign

POST-FLIGHT REPORT

November 30, 2004

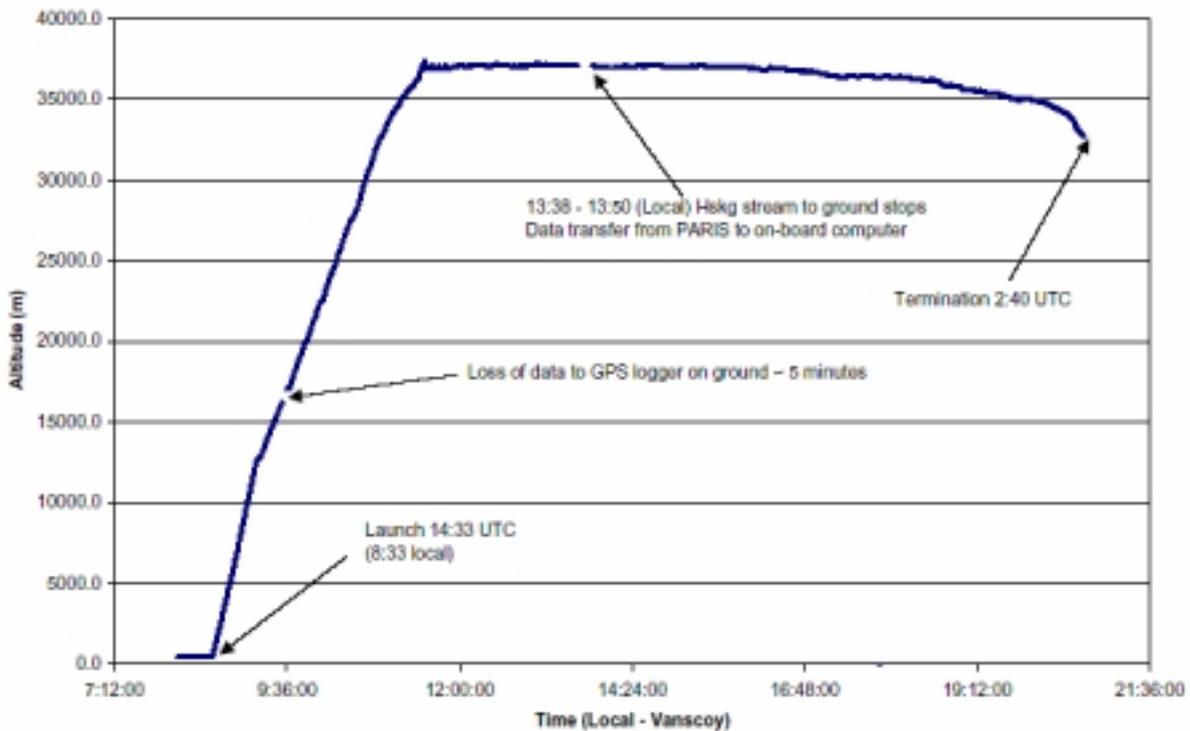
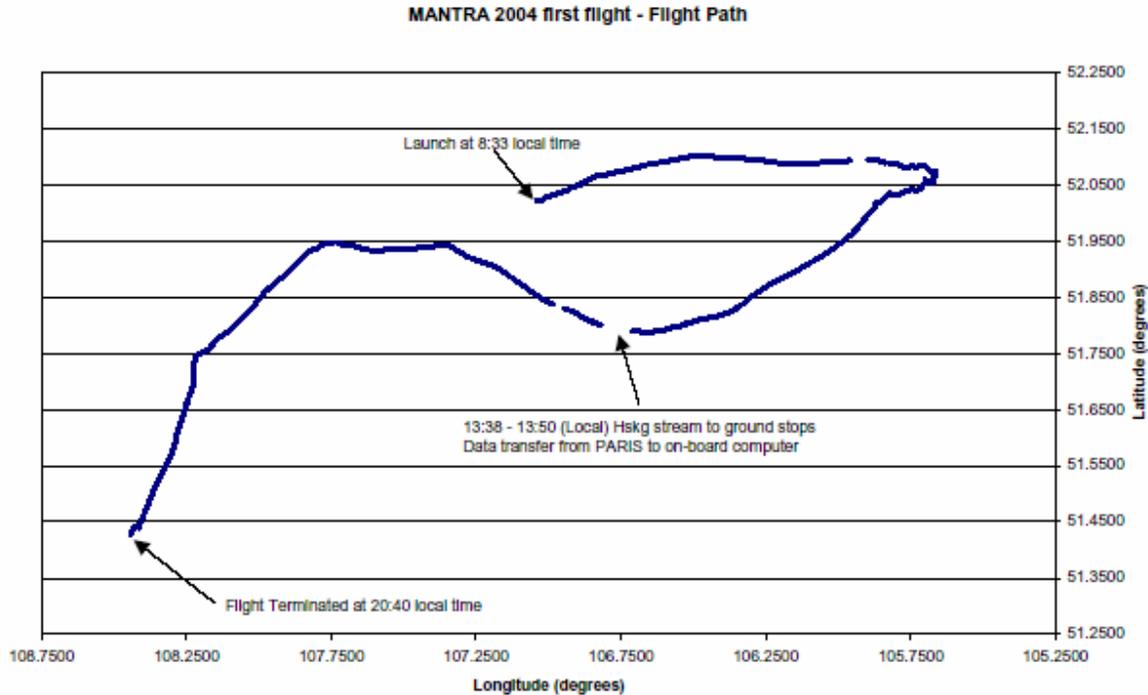
The launch at 8:30 AM local time (14:30 UT) went very smoothly. Because of the high humidity level the balloon disappeared in the fog shortly after launch. The balloon reached its maximum altitude of 37.185 km at around 11:30 AM. Command capability (uplink) to the gondola was lost at 9:12 AM when the balloon was at an altitude of 12.80 km and at a range of 46 km. An aircraft was sent to the area in an attempt to send commands from a longer range but this did not work either. At 8:56 AM, at a range of 18 km and an altitude of 8.02 km, the telemetry monitors from the upper CIP (termination pack) failed and never returned. The pointing system was launched in solar mode and was performing very well. However, at 04:16 PM it overheated and stopped working. The gondola then started to spin. A decision was made to wait till for the twilight in the hope some useful data could still be acquired. The flight was then terminated at 8:40 PM local time. Detail reports on the pointing system and on the failure assessments were provided by SIL and are appended here.

The flight profile is shown in the figures below (provided by SIL using PARIS GPS data)

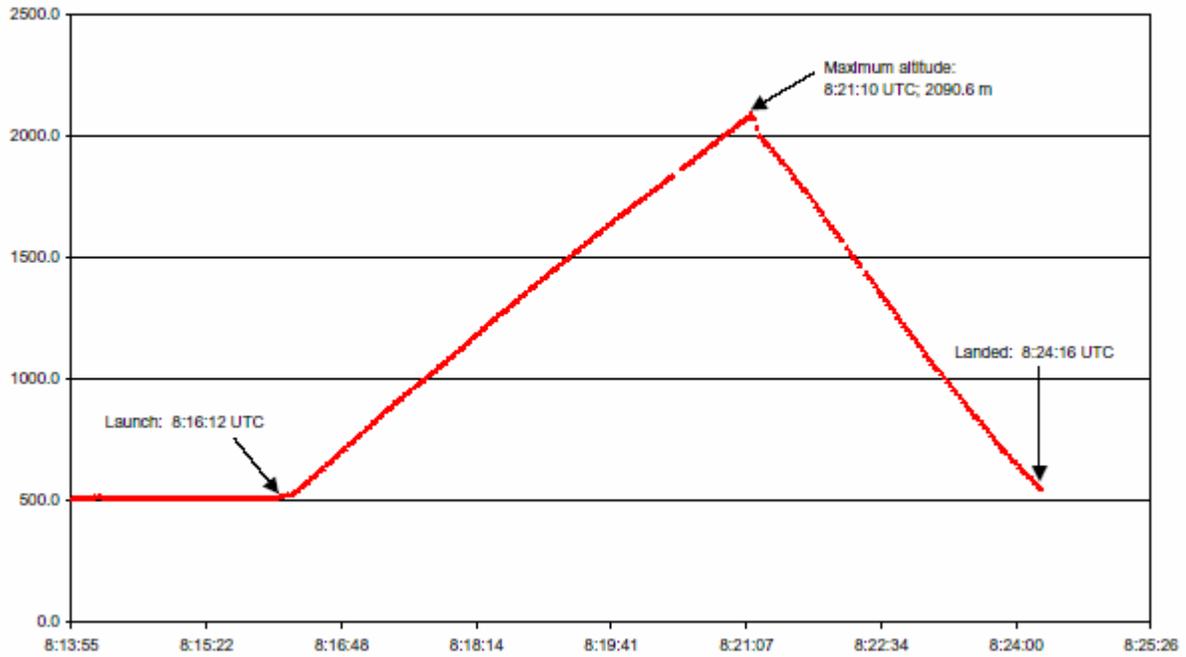
MANTRA 2004 flight 2 - September 14, 2004 - GPS ALTITUDE

The payload was recovered right after the flight termination. A pre-assessment of the failures was made in the field but all the analyses were non conclusive. Causes for the premature flight termination could not be clearly identified. Therefore, the team decided terminate the campaign on September 15 and proceed with a detail analysis of the events. All the instruments were packed next day and shipped back to Toronto on September 15. The science team left the field on September 16.

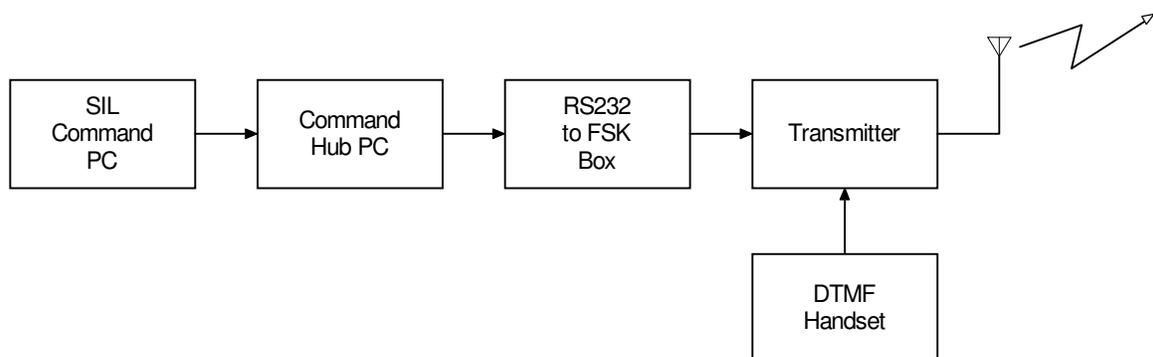
Figure 1 – Mantra 2004 Uplink Command System

At the payload main CIP the audio output of a 138.54 MHz receiver is fed to an FSK-TTL converter where the 300-baud stream enters the payload hub micro-controller and one of several SIL command decoders. The micro-controller generates the original command stream and delivers it to the proper destination. If the destination is an SIL command decoder then the payload hub micro-controller ignores the signal and the data stream includes addressing info to select the appropriate command decoder. Since the RF data uplink is at 300-baud and the original command stream can be as high as 9600-baud there will be some delay. Additional delays will occur since the command system is based on a first come first serve concept. The maximum length of a command string is 27 bytes and the byte protocol must be no parity, 8 data bits, 1 stop bit.

At the upper CIP the audio output of a second 138.54 MHz receiver is fed to a DTMF decoder and an FSK-TTL converter whose 300-baud output stream enters an SIL command decoder. The command decoder has 16 digital output lines, 8 of which are fed to a relay interface board. The relay interface board houses the drive circuitry to actuate the relays which in turn are used to perform various flight train functions like valving of helium, chute cutaway, and command terminate. To send a “command terminate” a password must be entered on the ground station computer. The output of the DTMF decoder directly drives a separate relay which in turn provides a second termination drive source (DTMF terminate). To send a “DTMF terminate” a unique timed sequence of four key presses need to be entered on the microphone keypad.

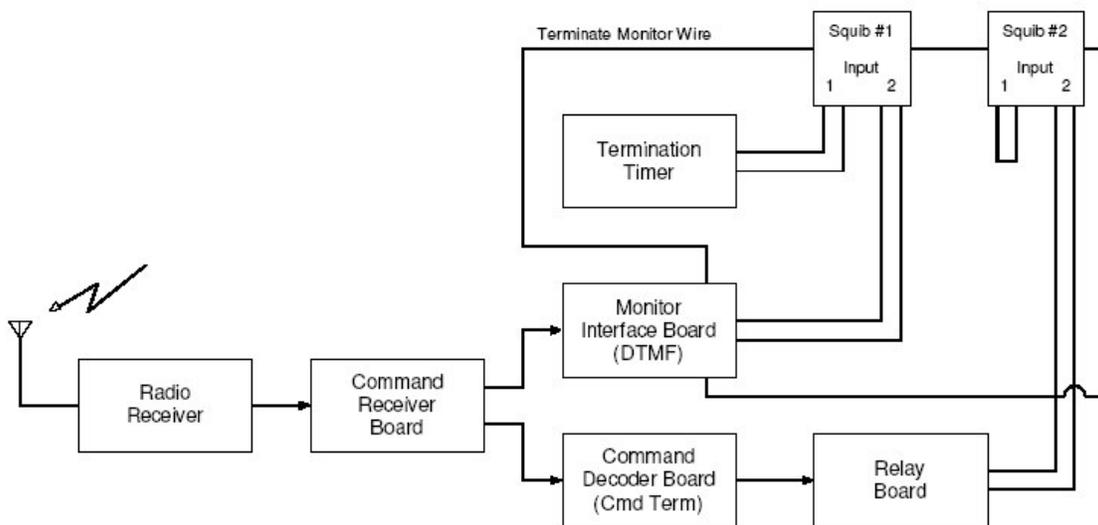
Figure 2 – Mantra 2004 Upper CIP Termination System

A termination fitting connects the bottom of the balloon to the top of the parachute. The fitting is held together by a 3/16 inch diameter steel cable. The fitting comes apart once the cable is cut by one of two explosive cable cutters. Each cutter has two inputs and for the second flight of Mantra 2004 one of the four inputs was not used. A monitor wire runs parallel to the termination cable and indicates when a cutter has fired by becoming open circuit.

When a termination command or DTMF command is received, the appropriate relay is actuated such that the pole (connected to +28V) gets connected to the normally open (N.O.) terminal. This places a voltage across one filament of a squib which will cause the cutter to fire. Additionally, a termination timer is set to countdown a specific number of hours and then output a voltage to fire a squib as a backup in the event of command loss.
